RAIN EROSION CHARACTERISTICS OF THERMAL PROTECTION SYSTEM MATERIALS AT SUBSONIC VELOCITIES

Bell Aerospace Company

Air Force Materials Laboratory

TECHNICAL REPORT AFML-TR-72-145

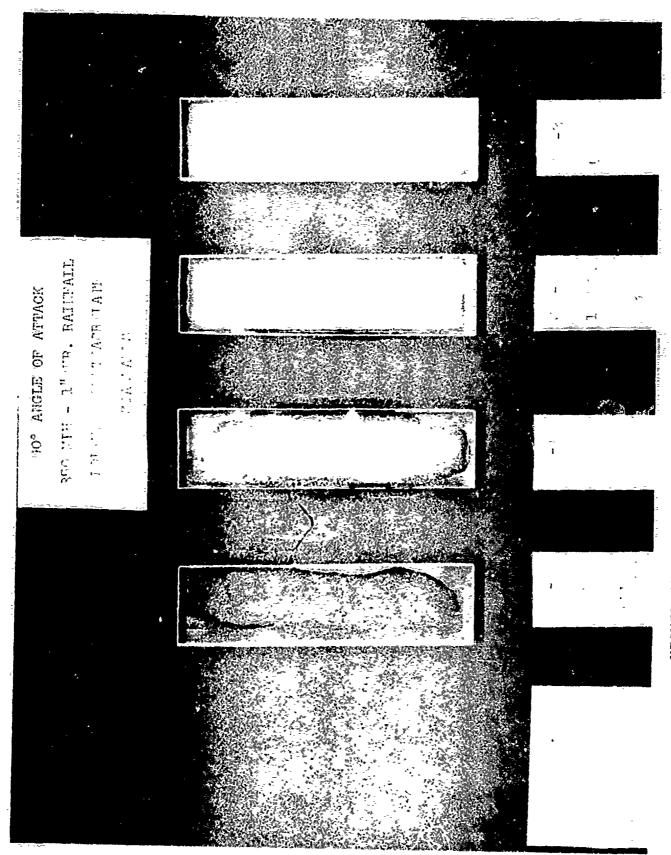
TGURE 27. TITTS ON PEMA STANDARD AT 350 MPH

The progression of erosion is shown in Figure 27.

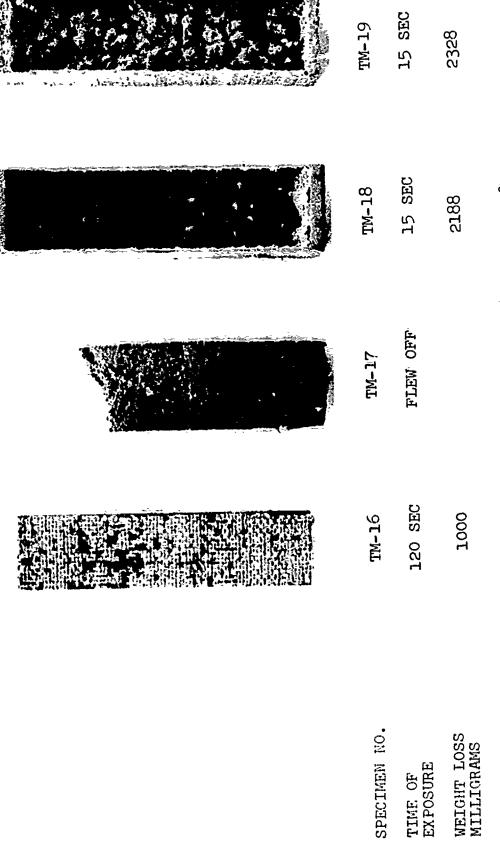
FIGURE 28. TESTS ON VARIOUS ABLATOR MATÉRIALS AT 90° - 350 MPH AND 1"/HR. RAINFALE

The remaining tests at 90 degree angle of attack were carried out at 350 mph and 1/2" and 1"/hr. rainfall. Figures 28 and 29 illustrate the severe erosion experienced by these insulation materials. These results illustrate the fact that erosion increases rapidly from 40 to 90 degree angles of attack at 350 mph.

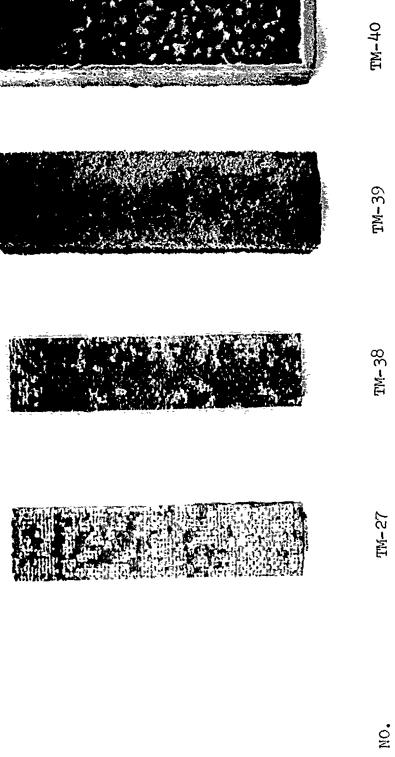
CDECTMEN NO		TM-27	TM-38	TM-39	TM-40
VELOCITY MPH		350	350	500	350
TIME OF		5 MIN	NIW 9	1 MIN	15 SEC
WEIGHT LOSS		1202	2419	51	1288
мтрыскыча	FIGURE 29.	TESTS ON VARIOUS 350 MPH AND 1/2	TESTS ON VARIOUS ABLATOR MATERIALS AT 90° 350 MPH AND 1/2"/HR. RAINFALL	AT 90° -
